## IMPORTANT

### Installation of Bilstein® Aftermarket Shock Absorbers on pre-1989 Chevrolet P30 chassis (part # B46-1404, B46-1501, B46-1587)

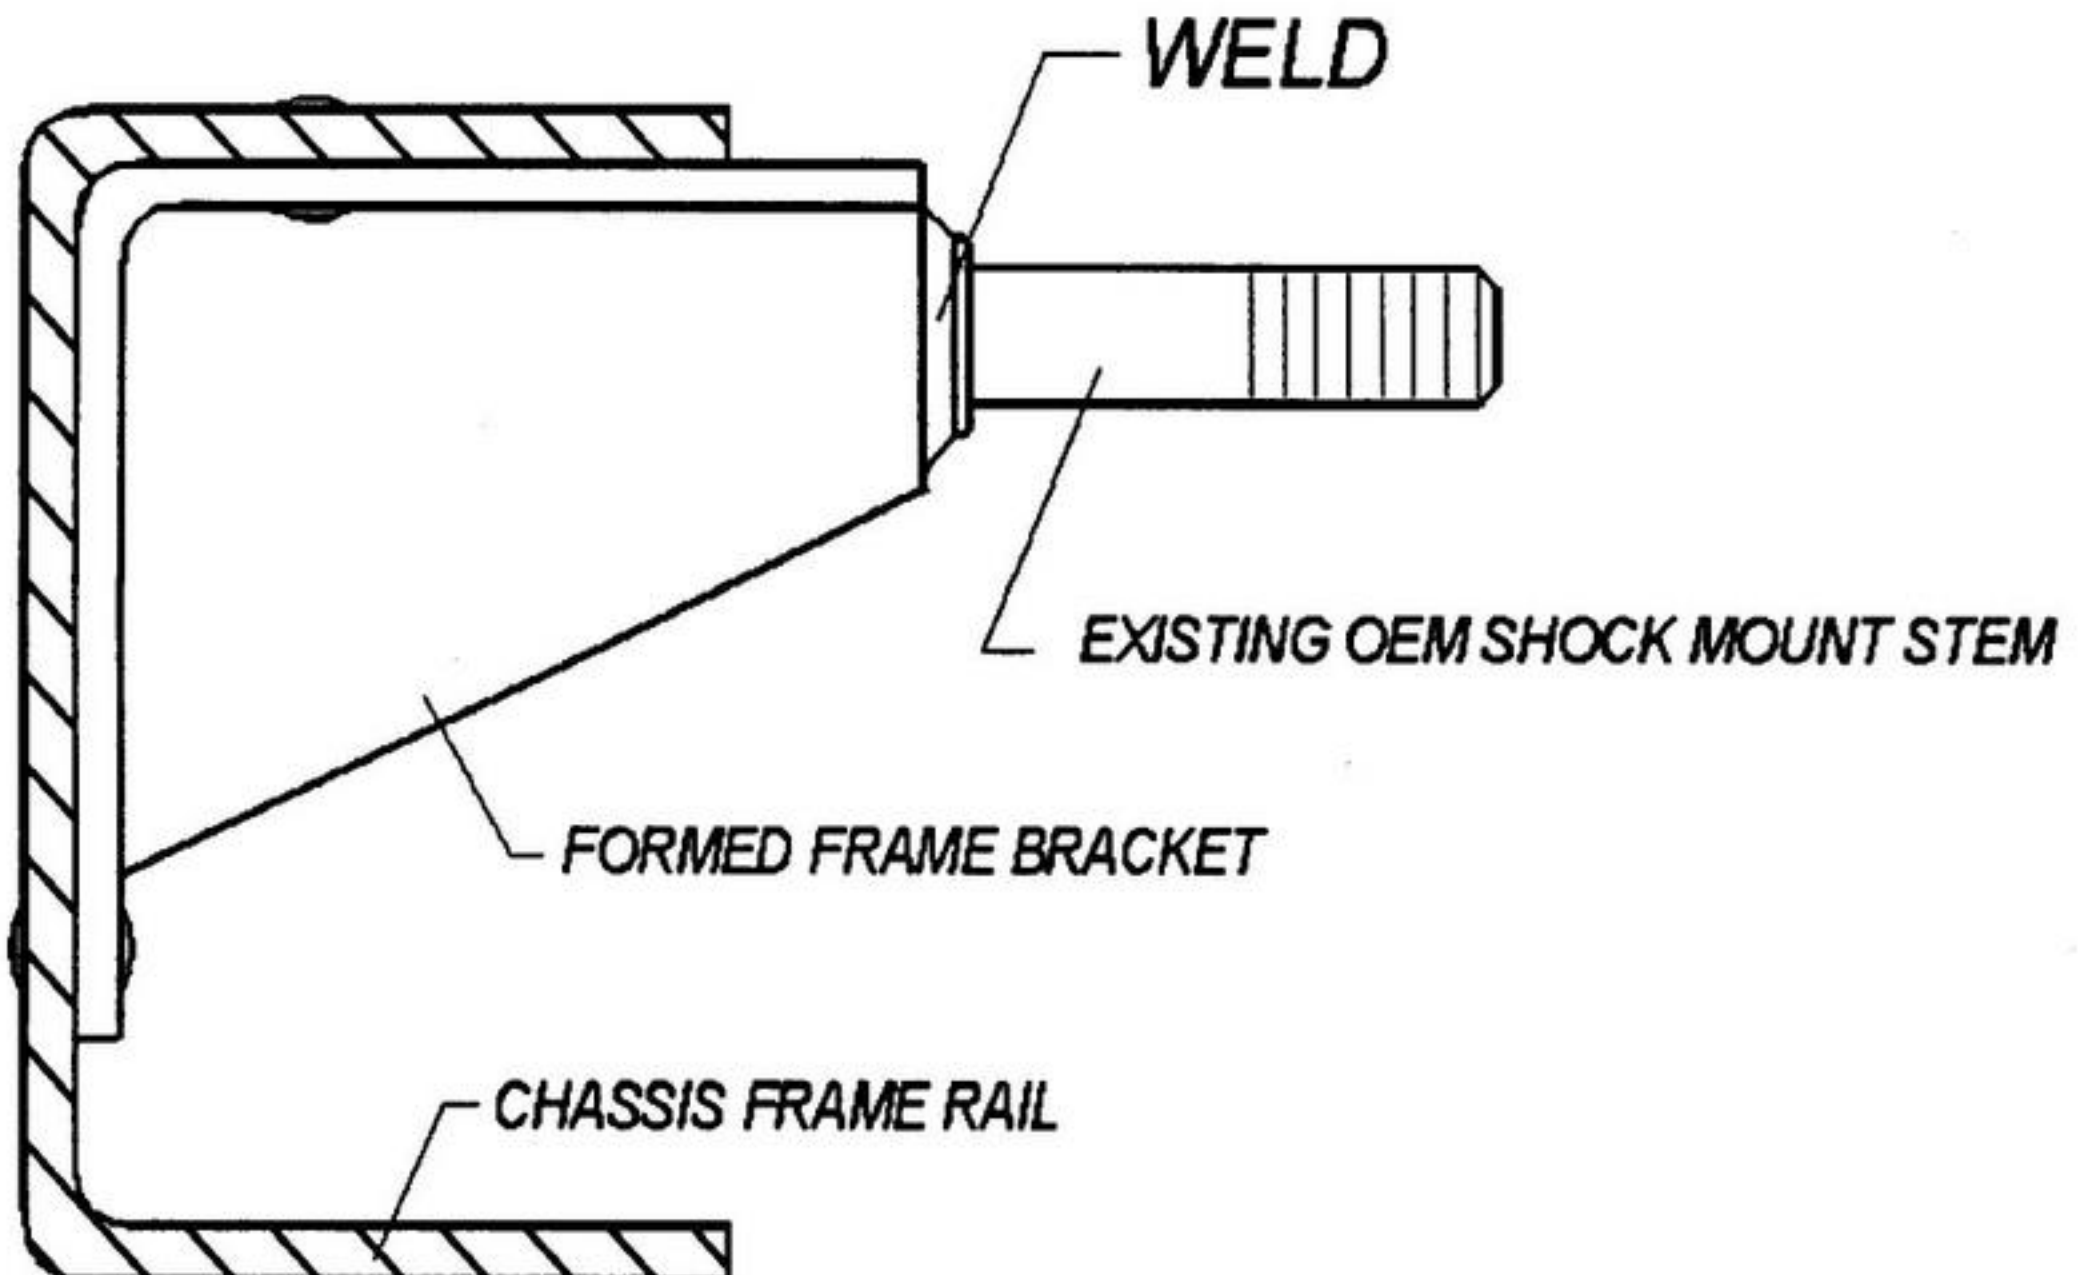
The upper OEM shock mount on pre-1989 Chevrolet P30 chassis is not sufficiently strong to support the damping loads produced by aftermarket shock absorbers. Those mounts must be reinforced to prevent fatigue failure.

The recommended reinforcement is to weld the existing OEM shock mount stem solidly to the formed frame bracket (see illustration below). **Before welding, ensure that all wires, cables, lines, and other flammable materials are properly shielded and protected, and that the area under the motorhome is well ventilated.**
